# Manhole Inspection Summary

Manhole # S290\_\_028MH

Insp Date: **11/18/08 10:19 AM**

**Location** Address: **1111 W. West**

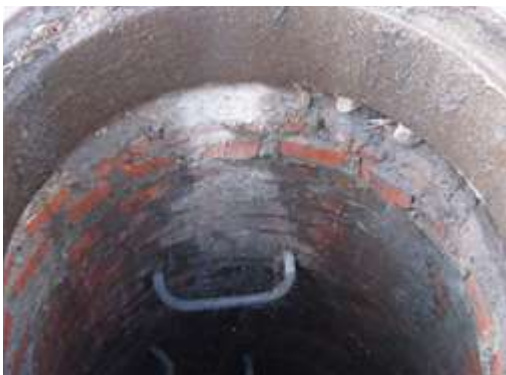
Defect 4

Condition: ☐ Sound ☒ **Cracked** ☐ Root Intrusion ☒ **Loose Brick** ☒ **Deteriorated**

deterioration, cracks and loose bricks in chimney

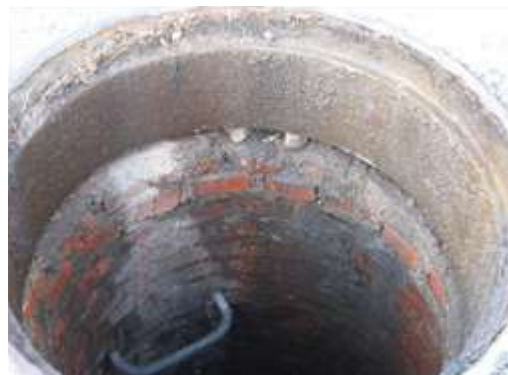
Defect 3

Infiltration: ☐ None ☒ **Joint** ☐ Cracks ☐ Mortar ☐ Roots ☒ **Wall**

Infiltration: ☐ None ☐ Joint ☐ Cracks ☐ Mortar ☐ Roots ☒ **Wall**

infiltration along chimney and corbel wall

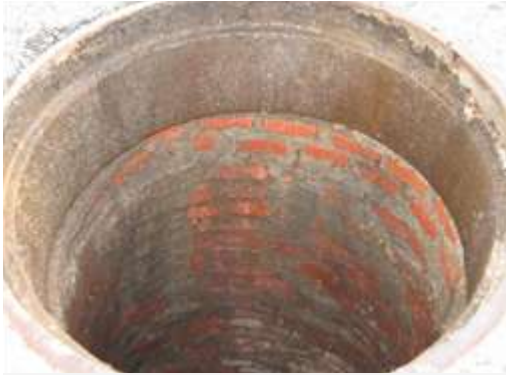
Defect 2

infiltration from top

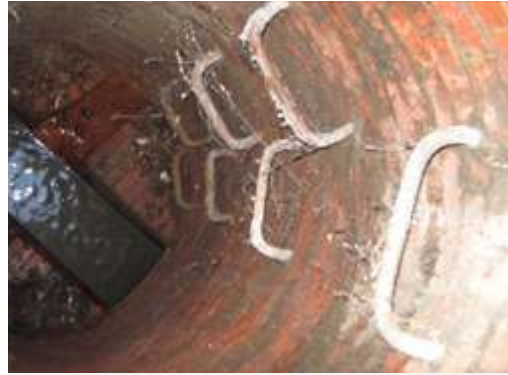
Defect 1

Count: **7** Missing: **0** ☒ **Corroded**

corroded steps

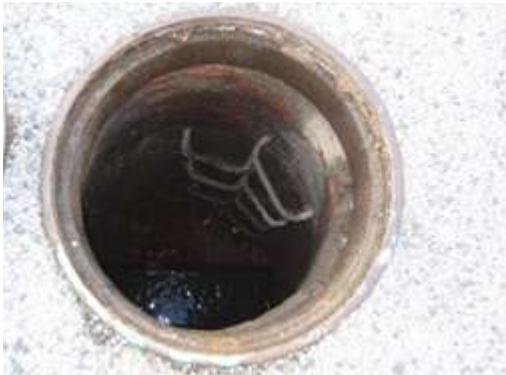
defect 5

Offset: **2** (in.)

Condition: ☐ Sound ☐ Cracked ☒ **Leaks**

frame offset 2"

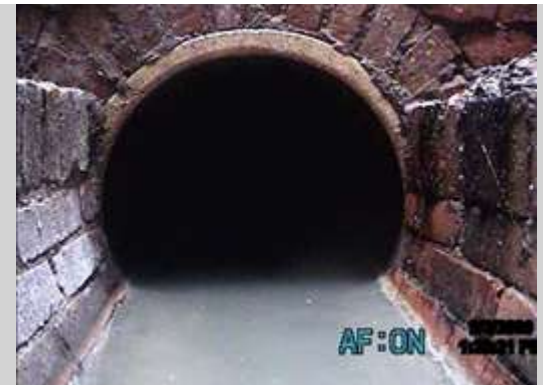
3 O'Clock Inflow

Pipe Height: **3.6** (in.) Direct (Angled)  
Pipe Material: **Clay** ☐ Pipe Lined  
Invert Depth: **11.80** (ft.) Flow Characteristics: **None**  
Deposits: ☐ None ☐ Mud ☐ Gravy ☒ Debris ☐ Grease  
Silt Depth: **6** (in.) Deposits Extent: **Heavy**  
Infiltration: **None** Pipe Seal Cond: **Sound**

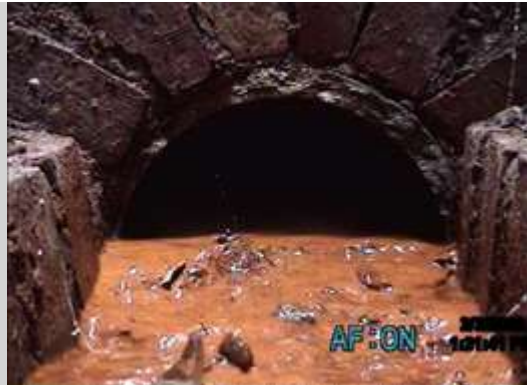
6 O'Clock Inflow

Deposits: ☐ None ☐ Mud ☒ **Sludge** ☐ Debris ☐ Grease

Silt Depth: **5** (in.) Deposits Extent: **Heavy**
